Asbestos

Control:

Surveys, Removal, and Management

Asbestos Control: Surveys, Removal, and Management—Second Edition

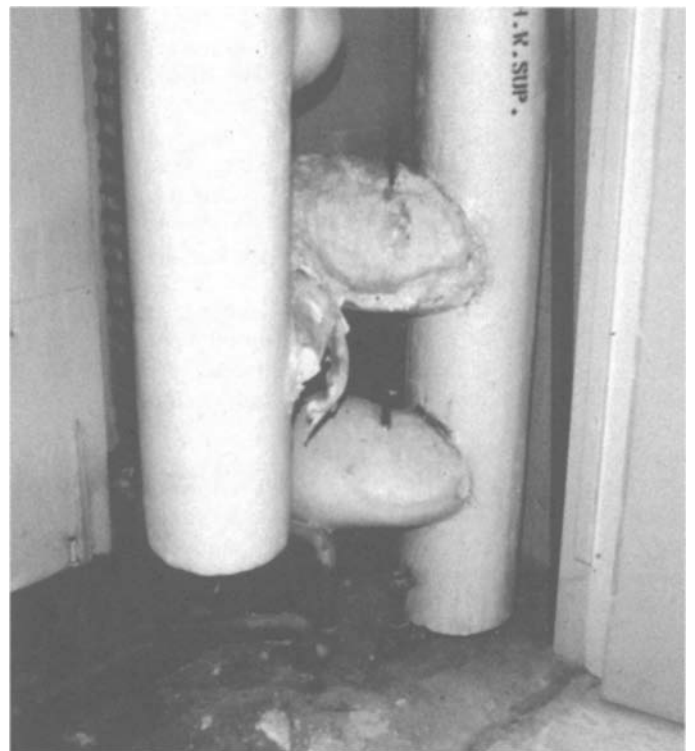
Fig. 15—Asbestos skim coat over fiberglass insulation.

An accredited inspector is allowed to identify specific types of *thermal system insulation*—fiberglass, foam glass, rubber, or other non-ACBM—as non-asbestos without bulk sampling according to §763.86 of the AHERA regulations. This section is also invoked by the OSHA standards for rebuttal of PACM in situations where that definition applies.⁴ The phrase “. . . or other non-ACBM” leaves a lot to the inspector's judgment—cork, for instance. Orange and yellow fiberglass insulation found on pipes and HVAC ducts will be the most common example. However, don't use this exemption as an excuse to avoid sampling the thin “skim coat” on fiberglass insulation (Fig. 15) or the mastic on HVAC ducts (Fig. 16).

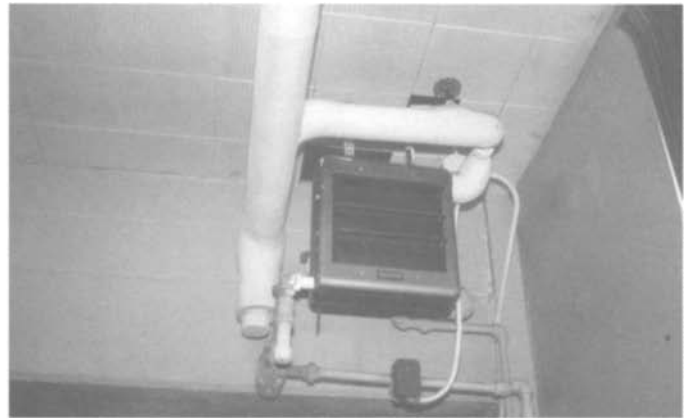
Fig. 17—Uninsulated condensate return lines on bottom of a unit heater.

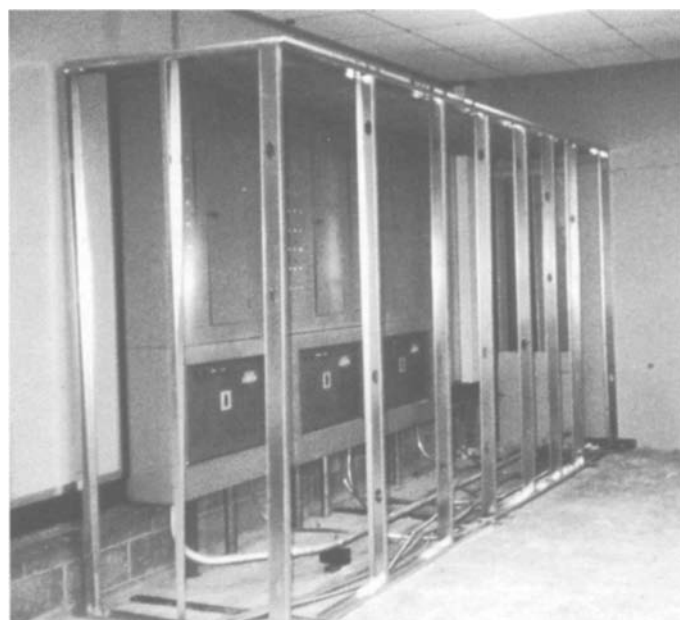
Fig. 32—Metal studs for temporary wall around electrical panels.

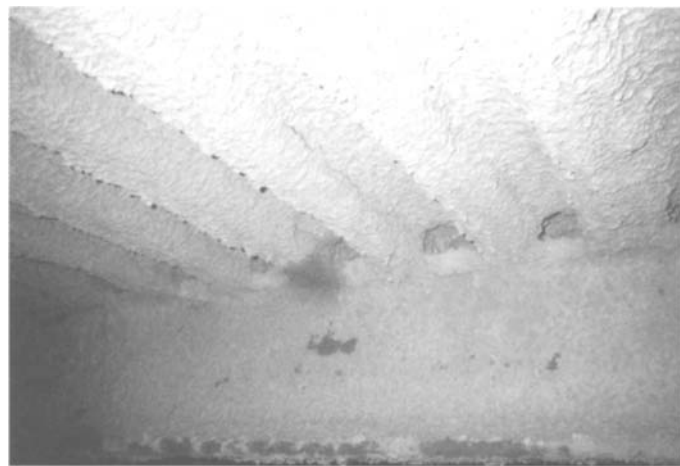
Fig. 36—Rust spots on fireproofing indicate condition of substrate.

Look closely at the condition of the substrate where it is visible, at the surface of fireproofing for spots that indicate rusted steel underneath (Fig. 36), and at the underside of ceilings and roof decks (Fig. 37) for evidence of water leaks.

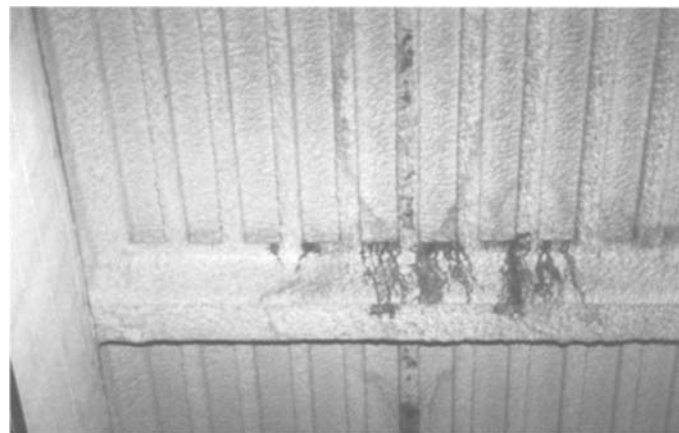
Fig. 37—Roof leak caused rusting of deck and beam.

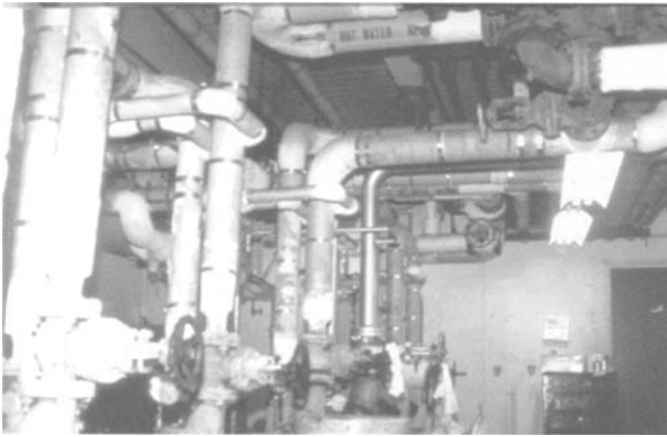
Fig. 38—Mechanical room pipes have short runs and many fittings.

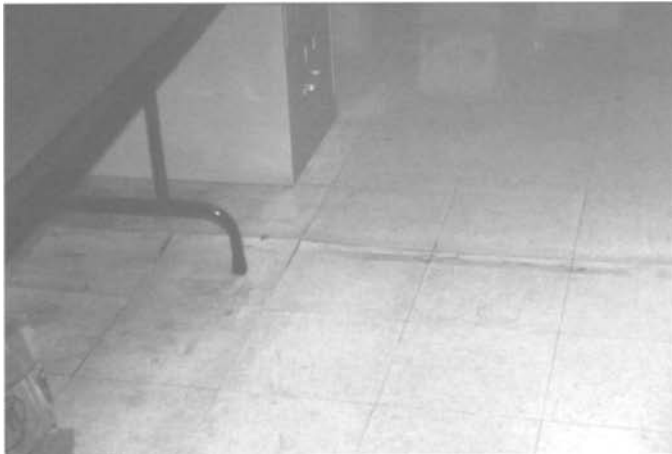
**Fig. 39—**Note damaged floor tiles under table.

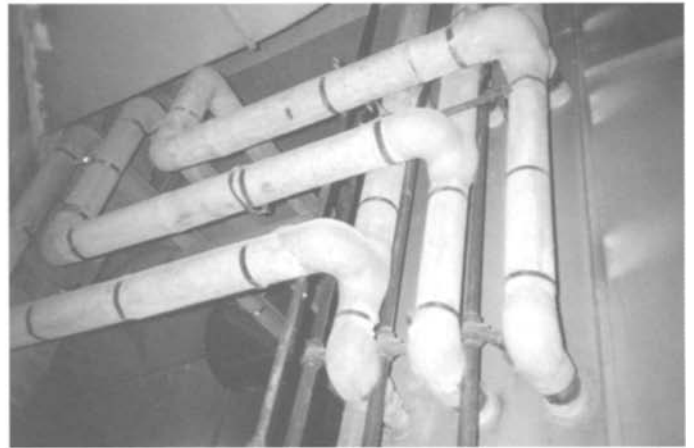
**Fig. 41—**Pipe insulation in “Good” condition.

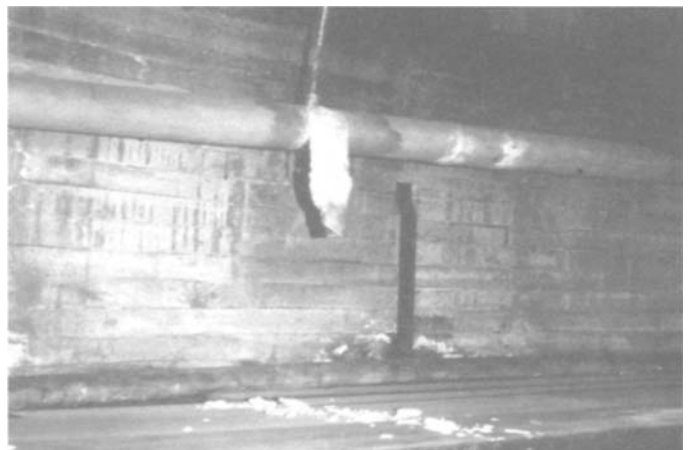
Fig. 51—Debris from pipe hanger insulation.

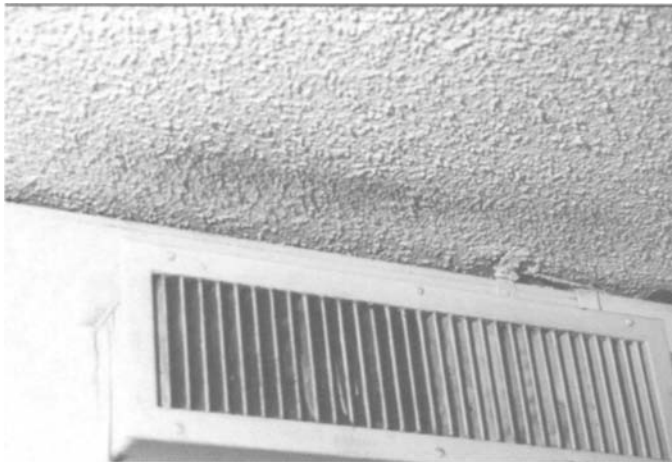
Fig. 52—Plaster ceiling eroded by dust from HVAC duct.

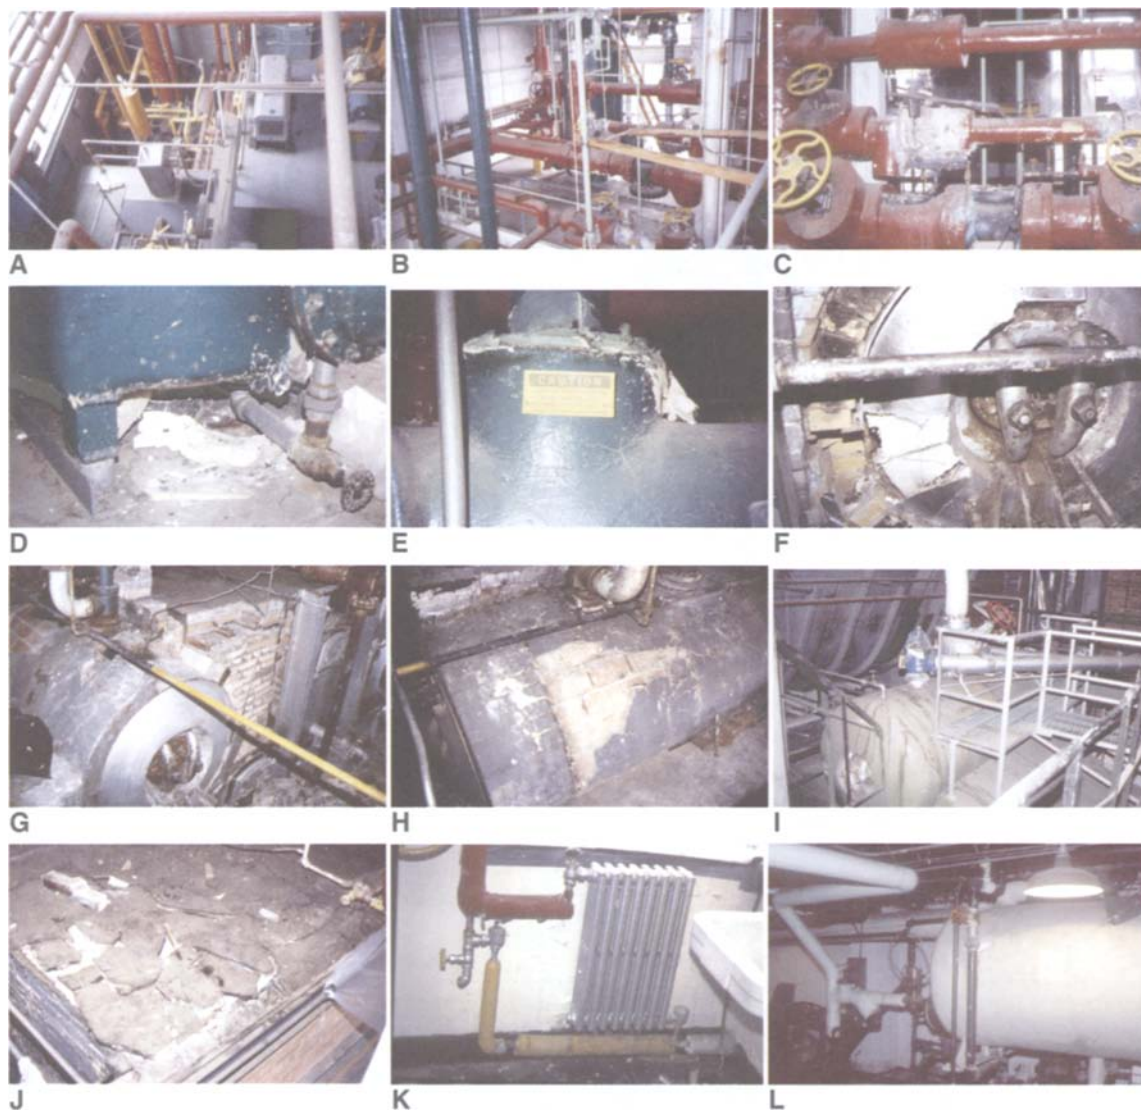
Fig. 57—Thermal system insulation in boiler plant. Pipes in corner pit **A**. Pipes on platform **B**. Damaged pipes **C**. Debris under tank **D**. Damaged fitting **E**. Steam drum-boiler #1 **F**. Steam drum-boiler #2 **G**. Steam drum-boiler #3 **H**. Steam drum-boiler #4 **I**. Boiler roofing **J**. Radiator pipes **K**. Hot water tank **L**.

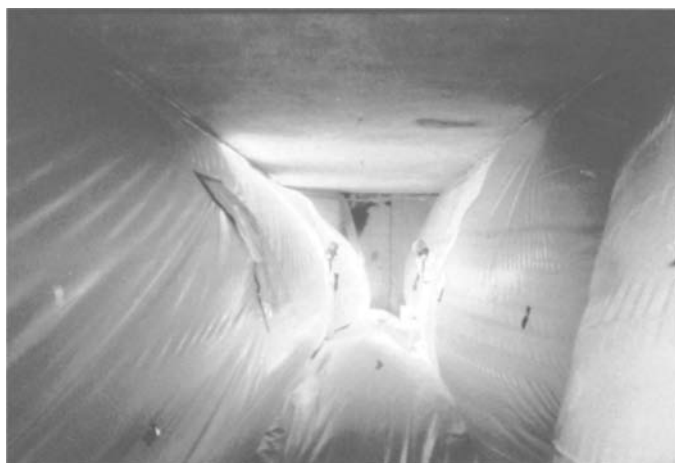
Fig. 79—Extreme case of air infiltration behind plastic sheets.

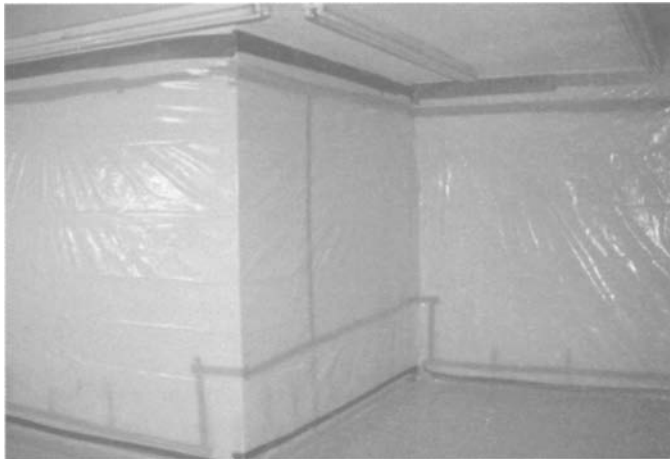
Fig. 80—Plastic for enclosure securely taped flat against walls and floor.

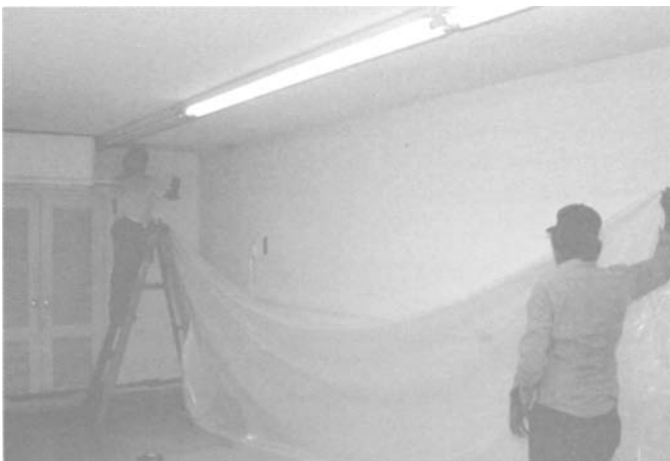
Fig. 81—Long expanses of plastic are difficult to keep attached to the wall.

Horizontal strips of duct tape should be backed up with spray adhesive to reduce the tendency of amended water to work its way under the top edge of the tape so that it eventually comes loose. There is a multitude of approaches to keeping plastic on the walls, such as by nailing the plastic to the wall with furring strips, and large, heavy hangings of plastic may need such reinforcement. Remember: 6-mil (0.15 mm) plastic is heavier than 4-mil; two layers weigh more than one; and the higher the wall, the heavier the plastic. Figure 81 shows a wall being covered with a long piece

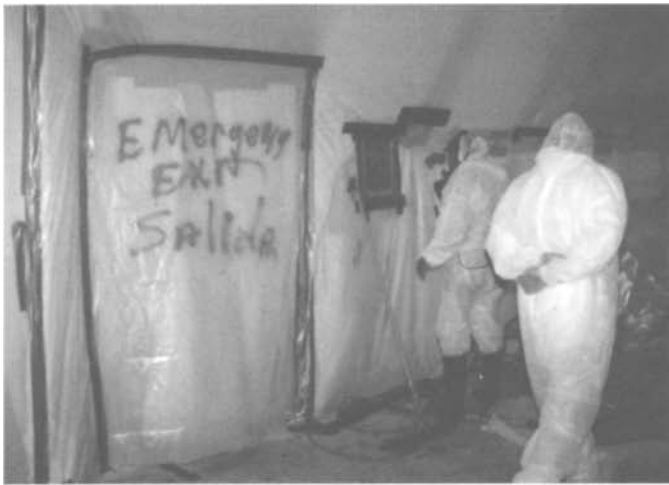
Fig. 97—Viewing port seen from inside enclosure.

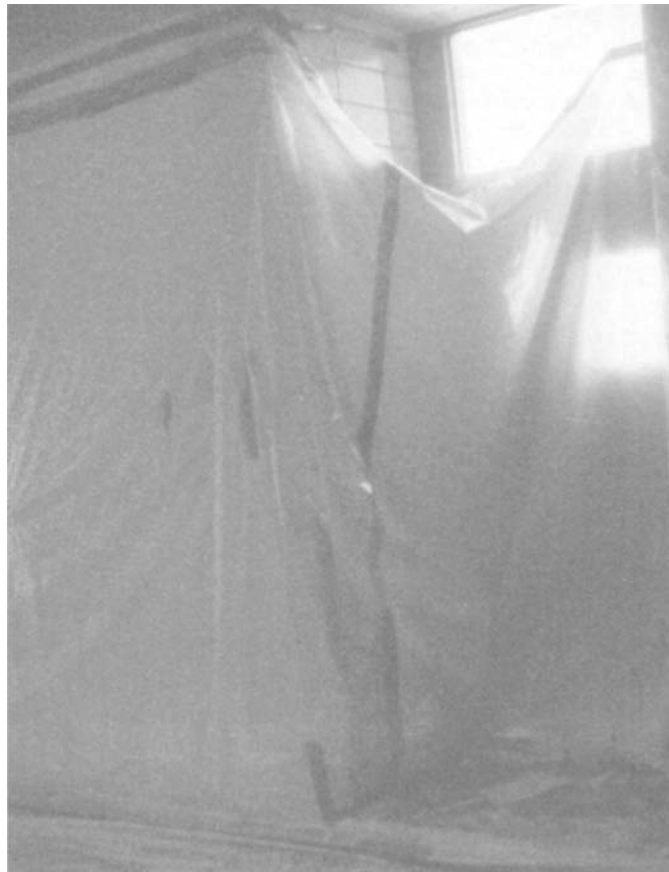
Fig. 106—Plastic hanging loose from wall during asbestos removal.

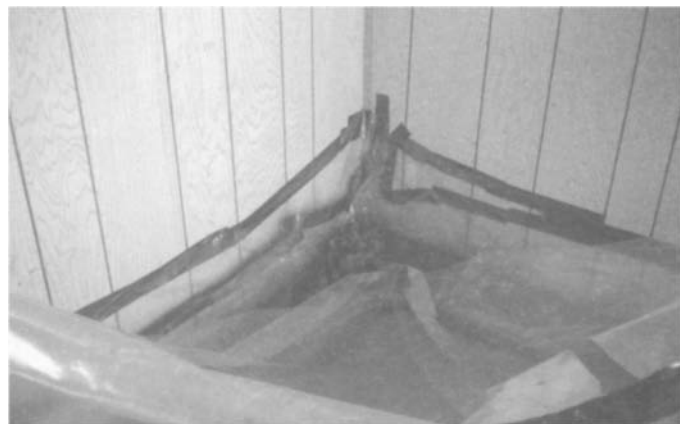
Fig. 107—Wall plastic has fallen completely away and carpet is contaminated.

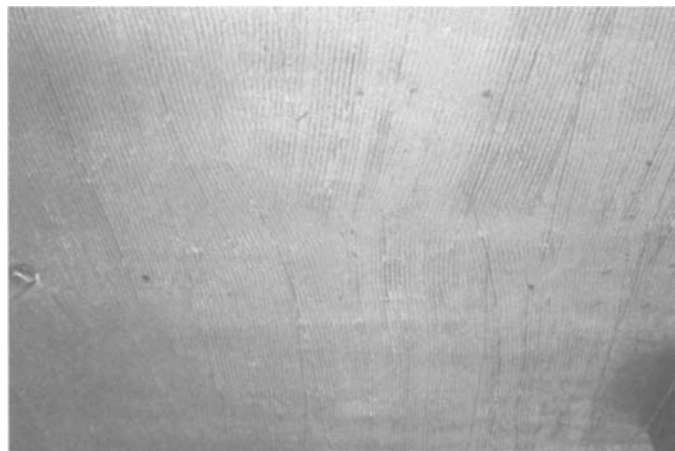
Fig. 108—Grooved ceiling cleaned of excessive residue.

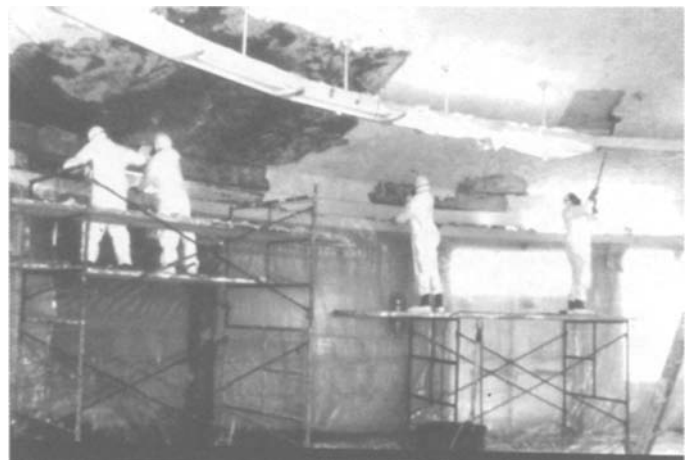
Fig. 112—Unacceptable conditions in removal area—work practices and safety hazards.

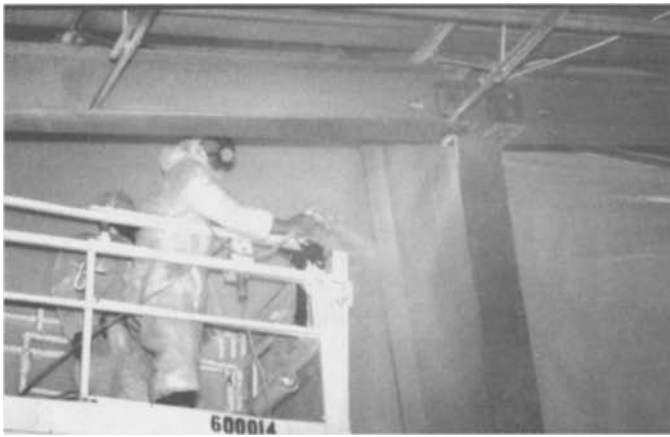
Fig. 133—Applying tinted sealer to beam after fireproofing was removed.

The sealer should be tinted for visibility to allow the project monitor to expeditiously verify that it is completely applied to the abated surfaces (Fig. 133). Since most sealers are water-based, tinting may be achieved simply by adding latex paint in many cases. The contractor is advised, however, to consult the manufacturer’s instructions for assurance that the intended tinting agent will not compromise the retrofit properties listed above. In some cases, there may be aesthetic reasons for preferring a clear (untinted) sealer, and these should be addressed during project design.

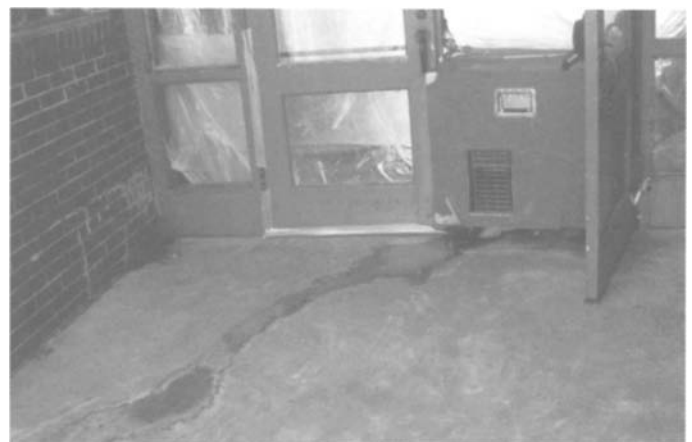
Fig. 139—Water and debris leaked through critical barrier to outside of building.

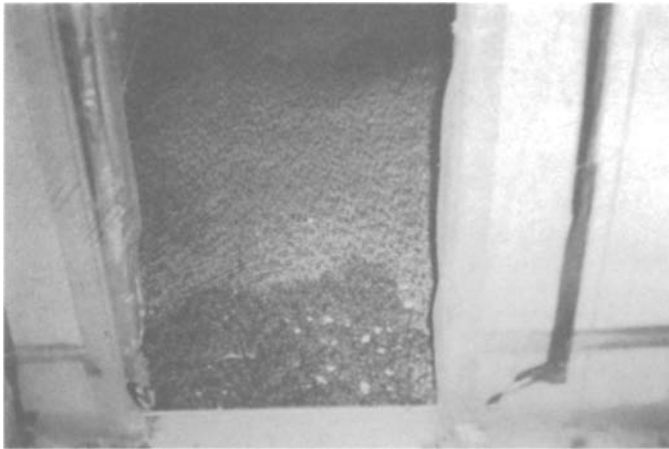
Fig. 140—Carpet is wet and contaminated due to leak in floor plastic.

Which option is more expensive is arguable, since “time is money” on an abatement project. If the carpeting stays wet for several days, there is a risk of mold and mildew appearing. Besides causing irreversible damage to the carpet, the mere presence of mold and mildew might be of great concern to the owner and occupants. To alleviate anxiety over possible health effects from the mold and mildew, the owner may insist on a mold remediation project after abatement is completed, at the expense of the abatement contractor.

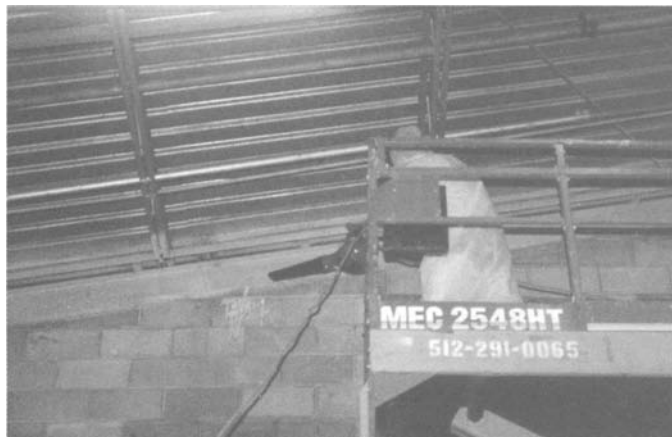
Fig. 144—Using leaf blower on beams near warehouse deck.

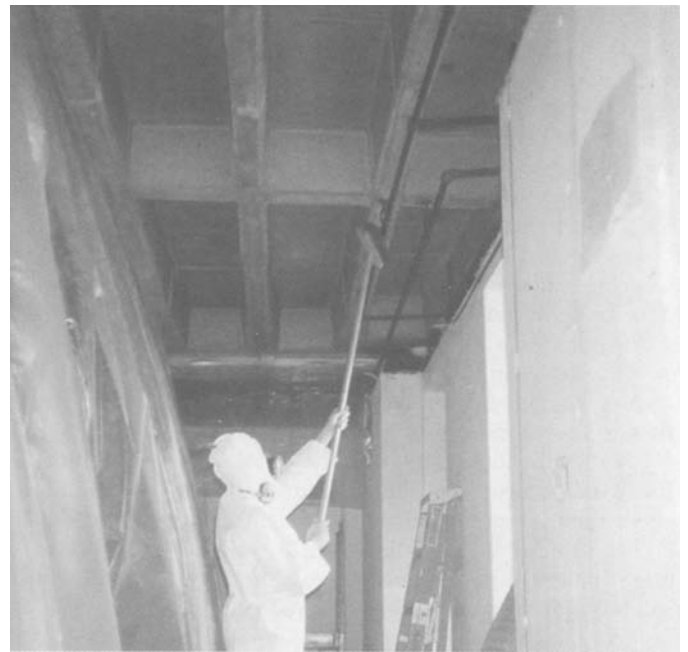
Fig. 145—Aggressive air sampling using brush to disturb pipes.

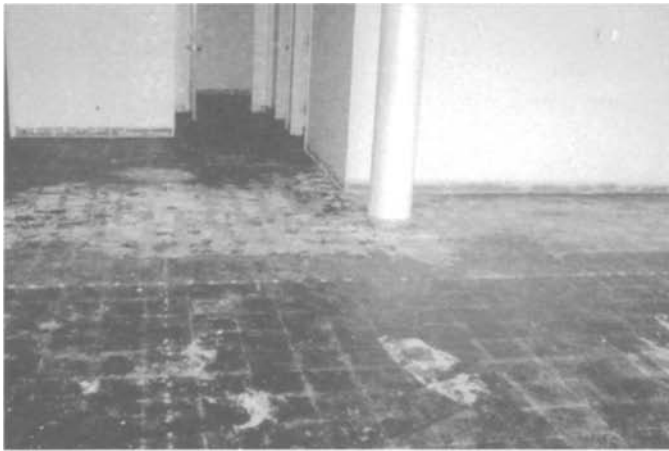
Fig. 148—Large areas of asbestos-containing asphalt mastic were left in this building.

Figure 148 was taken in a building where 100 000 ft² (9290 m²) of asbestos floor tile was removed but the asbestos-containing asphalt mastic was left. The owner was unsure if he was going to renovate or demolish the building—if it was renovated the flooring contractor would probably have taken a sander to the entire floor. Large areas had

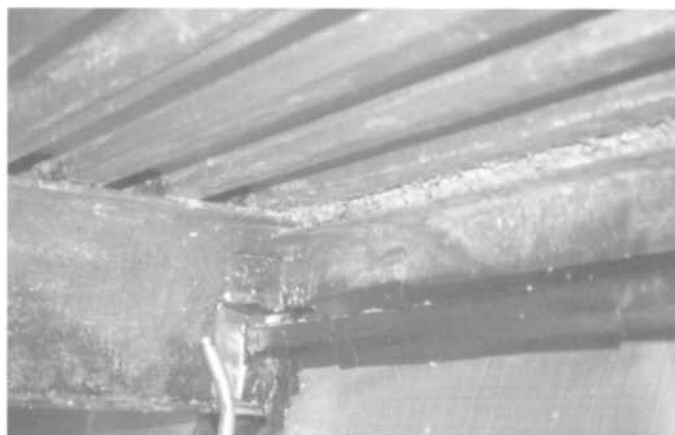
Fig. 182—Fireproofing between deck and beam above critical barrier.

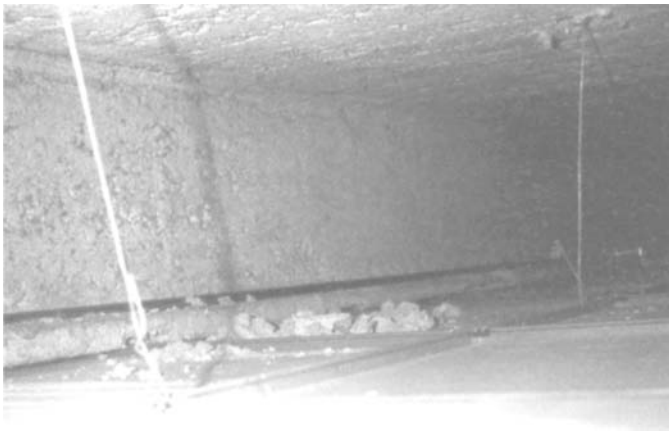
Fig. 196—Fireproofing debris on top of ceiling tile.

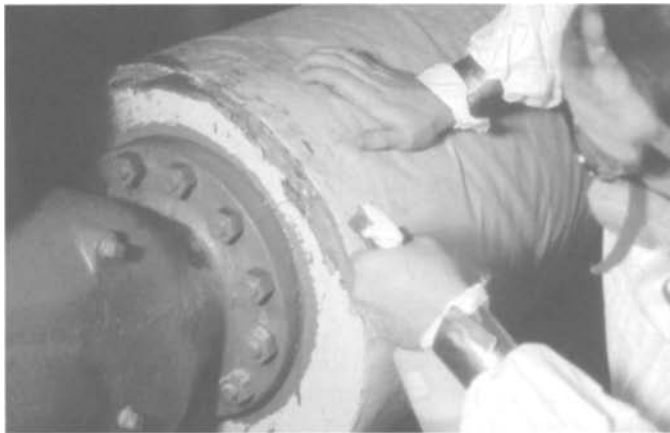
Fig. 199—Wetting damaged insulation to be repaired.

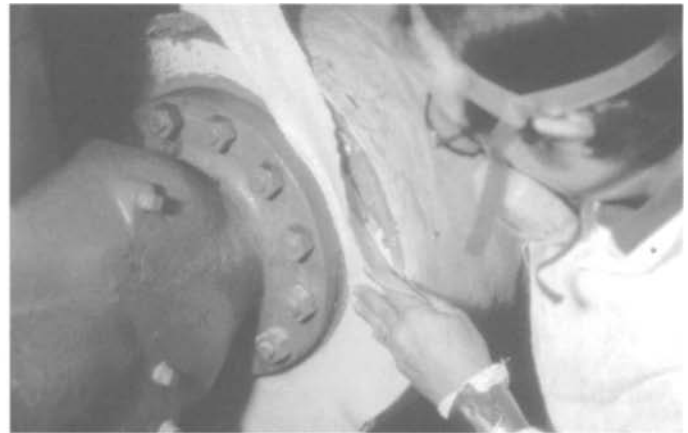
Fig. 200—Applying wet adhesive cloth to damaged area.

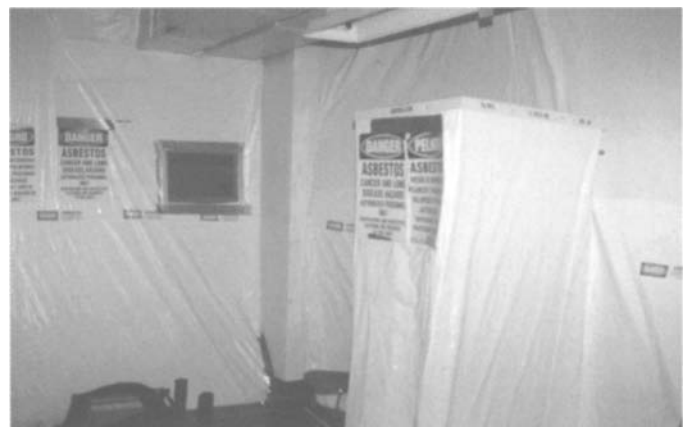
Fig. 201—Test chamber for Initial Exposure Assessment.

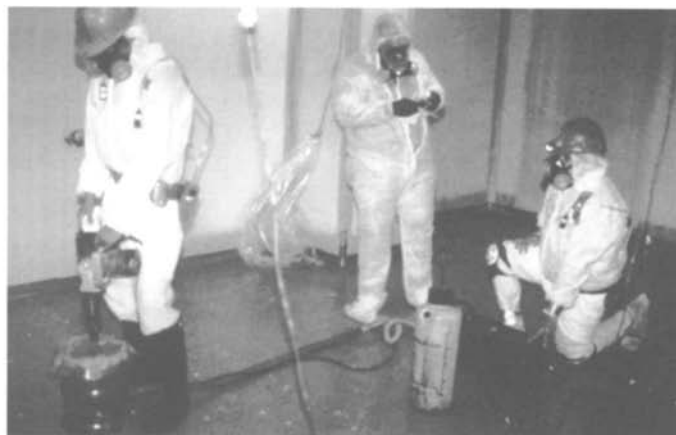
Fig. 203—Abatement worker drilling holes with HEPA-filtered vacuum shroud.
